# New statues at Karnak

A surprising discovery was made during recent consolidation work on the fourth pylon of the temple of Amun at Karnak. **François Larché** reports.

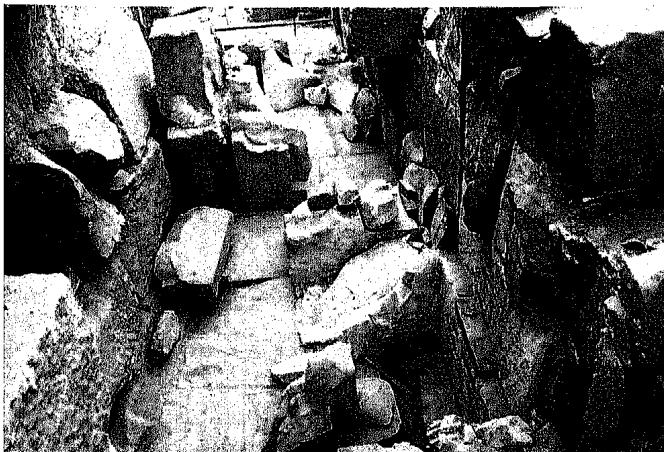
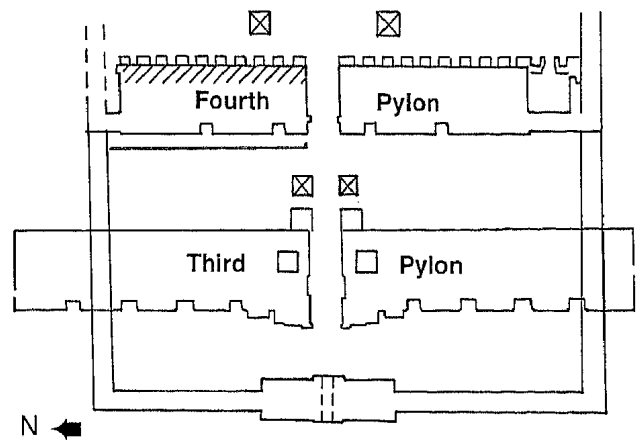
**Blue:** constructions of Tuthmosis III-Amenhotep III.

**Red:** constructions of Tuthmosis I-II (the hatched area shows the location of the 'seam' of limestone with the niches and remains of statues).

**Green:** location where the east wall of the columned portico of Tuthmosis IV will be reconstructed.

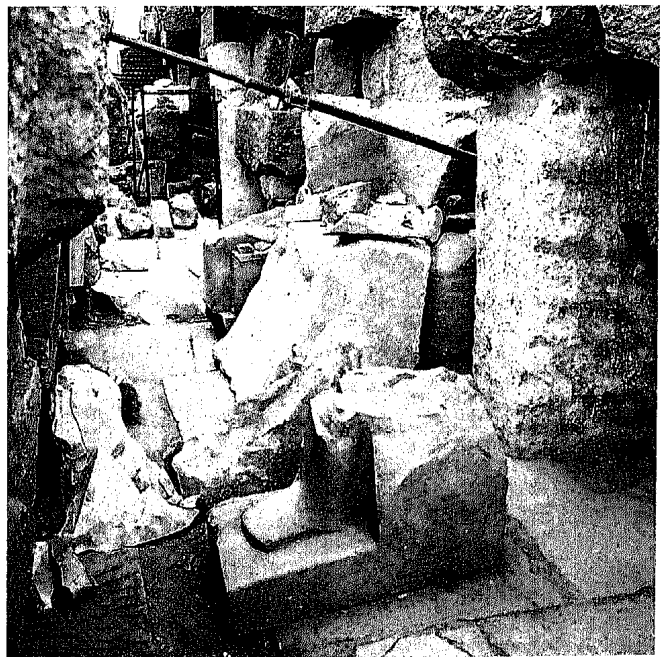
Karnak, fourth pylon. Views of the remains of the sandstone statues and the limestone niches from the south-east (left) and from the north-east (right)

The consolidation of the pylon itself led to the discovery by Christophe Chini of the remains of four of an original eight niches built of limestone and incorporated into an earlier, previously-undetected pylon façade on the east side of the fourth pylon's north wing. The niches, built at the same time as the core of the pylon and part of the same original construction, still contained the lower portions of seated sandstone Osirid statues. Columns of text inscribed on the thrones of all four of the statues state that they were made in the name of Tuthmosis I by Hatshepsut. Numerous fragments of inscribed limestone in sunk relief came from the door-frames of the niches; one bears a particularly well-preserved cartouche with the name of Tuthmosis I. Another fragment originating from a lintel block, with a winged disc surmounted by a base-line on which a large foot is visible, indicates that above the niches there was a large-scale relief scene which probably covered the east face of the pylon.
